From Mike Pullen, Multnomah County

SE Stark Street Reopens After Culvert Replacement

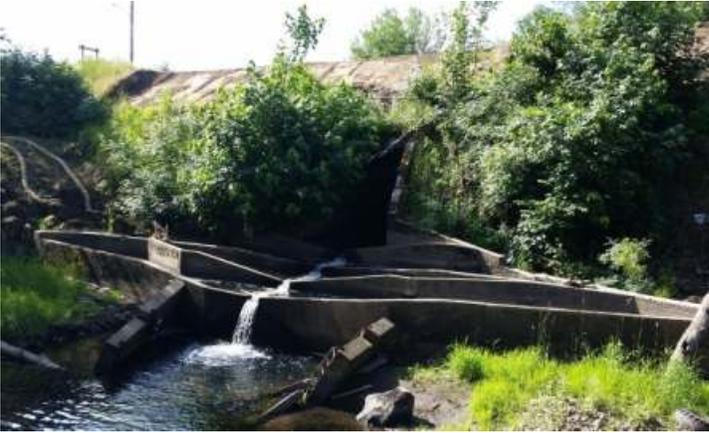
Broken fish ladder removed.

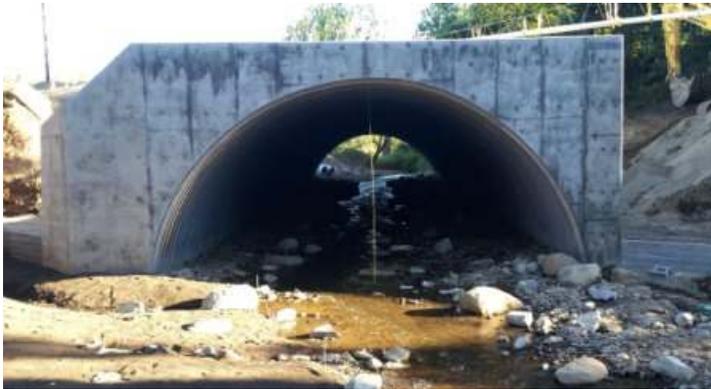
Downstream headwall of culvert.
The fish ladder was not replaced,
as the culvert has a natural stream
bottom.
